Case Study Remediation in Neath Port Talbot

St Modwen Developments

Remediation Approach

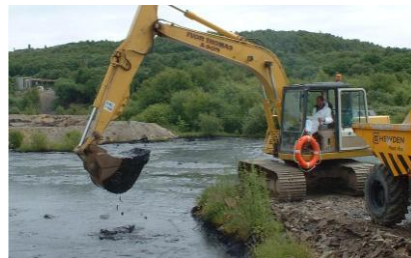
Historical land-use that has resulted in the release of contamination to the ground and groundwater.

The principal contaminants:

- Petroleum hydrocarbons
- Chlorinated Solvents
- Metals and Asbestos
- Varied spatial distribution

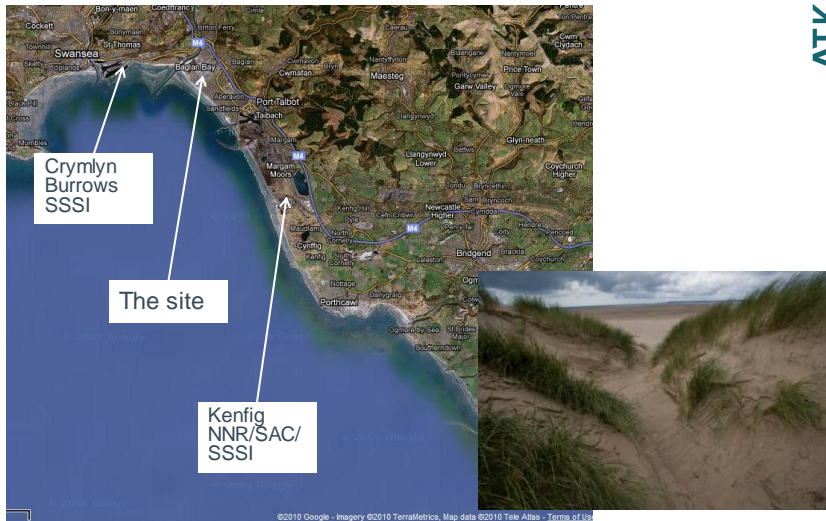
Dune Complex to Chemical Works

Site developed progressively from 1960s

Sand dunes levelled

Slag from nearby steel/ironworks imported

Maximum extent/operation in late 70s, wind down and demolition in 80s and 90s

Last facility removed in 2005

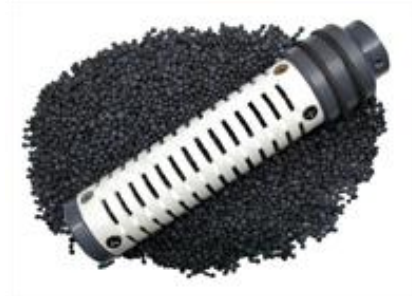
Microbial Studies

How do you demonstrate MNA?

Aim: to get definitive proof that

- The right microbes are there
 - Cultures, gene counts using qPCR
- The microbes are doing what they are supposed to
 - Baited traps using C-13-labeled contaminant
 - C-13 ends up mineralised and in the biomass.
 - Benzene and phenol both used.

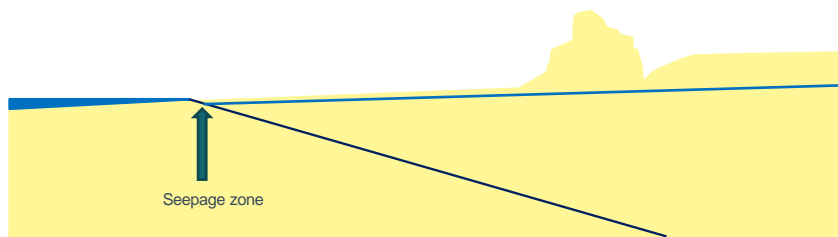
Risk Assessment – Human health

Key issues:

- Who uses the beach?
- How much do they use it?
- How do they come into contact with contamination?

- CCTV recording of beach
- Dog walkers main users, duration can be estimated
- Loads of monitoring to understand exposure
 - Contaminated water close to low tide

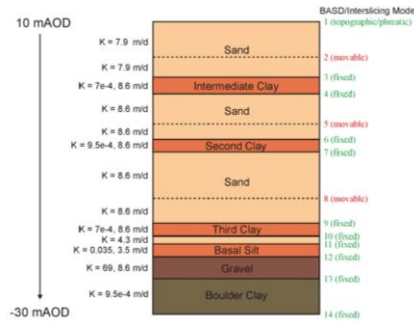
Risk Assessment – Controlled Waters

Styrene areas key remediation objective

- Aquifer properties well known
 - Site testing, CSIRO model
 - MNA occurrence being demonstrated
 - Infiltration high – flushing
- Declining source appropriate?
 - But check equations carefully
 - Decline of soil source or just assume that one pore volume of contamination
